# Pelvic Pseudotumor

## An Unusual Presentation of an Extra-Articular Granuloma in a Well-Fixed Total Hip Arthroplasty

**Abstract:** A 76-year-old woman developed a pelvic mass and abdominal pain 12 years after cementless total hip arthroplasty. The mass was a cystic granuloma that communicated with the hip joint via a soft tissue herniation under the inguinal ligament. There was no acetabular lysis or defects. The shell and femoral component were well fixed, the polyethylene was worn, and a liner exchange was undertaken. The cyst was debrided, and follow-up computed tomography demonstrated resolution of the granuloma and no recurrence of the cyst. Removal of the source of the particle wear debris via liner exchange or revision surgery combined with cyst debridement via a single incision is recommended. **Key words:** pelvic pseudotumor, total hip joint arthroplasty, granulomatous mass, particle wear debris.

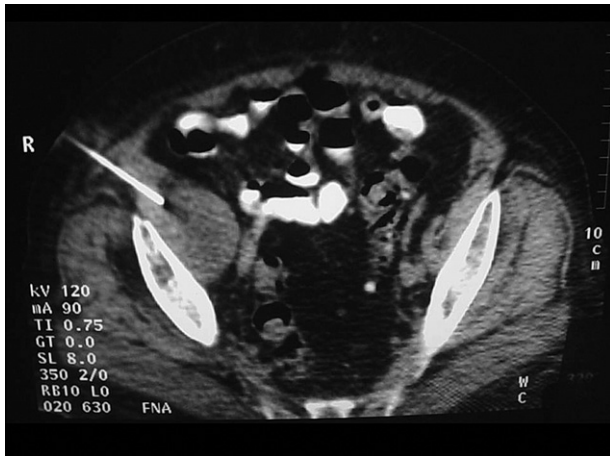
**Fig. 1.** Computed tomography scan of the pelvis showing a space-occupying mass in the right iliac fossa along the iliopsoas muscle adjacent to anterior aspect of acetabulum. The needle used in the biopsy of the cyst is seen in this slice.

seek medical attention at that time. In 2004, she developed acute abdominal pain and presented to the accident and emergency department. She was found to have a painful mass in her right iliac fossa and was admitted under the care of the general surgical service. Pelvic ultrasound identified a hypoechoic mass along her right psoas muscle. A contrast computed tomography (CT) scan (Fig. 1) demonstrated a large intrapelvic cyst 90 mm in length; CT-guided biopsy demonstrated abundant acellular eosinophilic materials, giant cells, and debris; no organisms were cultured and no malignant cells seen (Fig. 2). Leukocyte count at that time was  $7.17 \times 10^9/L$ , erythrocyte sedimentation rate was 48 seconds, and C-reactive protein was 12. A plain radiograph of her right hip demonstrated

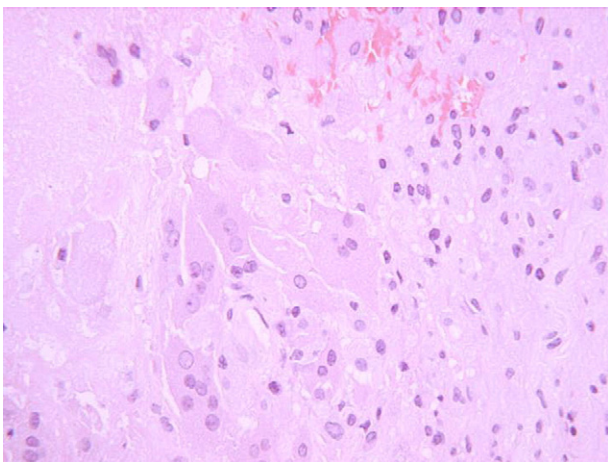
**Fig. 2.** Histophotomicrograph of the cyst demonstrating giant cells at the edge of necrosis with foamy eosinophilic cytoplasm. Consistent with a long-term granulomatous reaction.

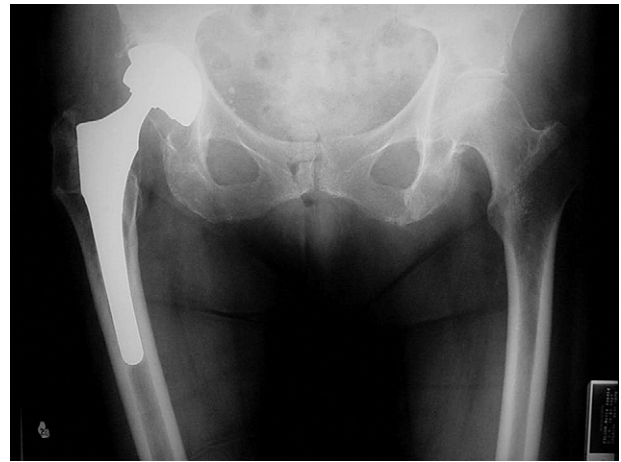
**Fig. 3.** Anteroposterior radiograph of the pelvis. There is eccentric wear of the right polyethylene liner. The acetabular and femoral components do not show evidence of loosening.

eccentric wear of the polyethylene liner with no evidence of cup loosening. The femoral stem was well fixed (Fig. 3).

Anteroposterior and lateral radiographs of the hip may demonstrate eccentric wear of a polyethylene liner. In this case, linear wear was calculated at 0.23 mm/y. Osteolysis of the acetabulum may be

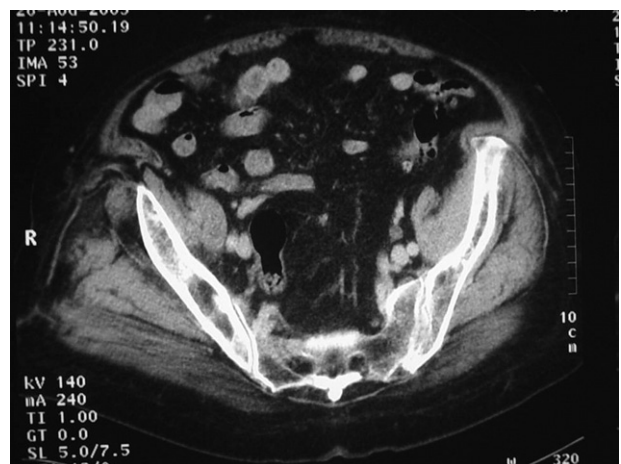
**Fig. 4.** Follow-up CT scan shows that the granuloma has been resolved, and there has been no recurrence of the cyst.

It was decided to explore the hip and decompress the cyst. An anterolateral approach was used; the acetabular shell and femoral components were solidly fixed. The neck of the cyst was located anteriorly to the acetabulum at the 4 o'clock position. This was decompressed, and curettings were sent for histology and culture. The acetabular liner was worn superiorly and was exchanged, as was the femoral head. The patient made a good recovery, and her abdominal pain was resolved. At a 2-year follow-up, in 2006, she was well and pain free, and repeat CT scan demonstrated no recurrence of the cyst, and the granuloma was resolving (Fig. 4).
